DEFENDANT'S EXPERT REPORT

**Re: George Collins and
Alrika Collins,
Plaintiffs,**

**State Farm Fire and
Casualty Company,
Defendant.**

**United States District Court for
the Eastern District of Oklahoma
Case #: 22-CV-00318-RAW-JAR**

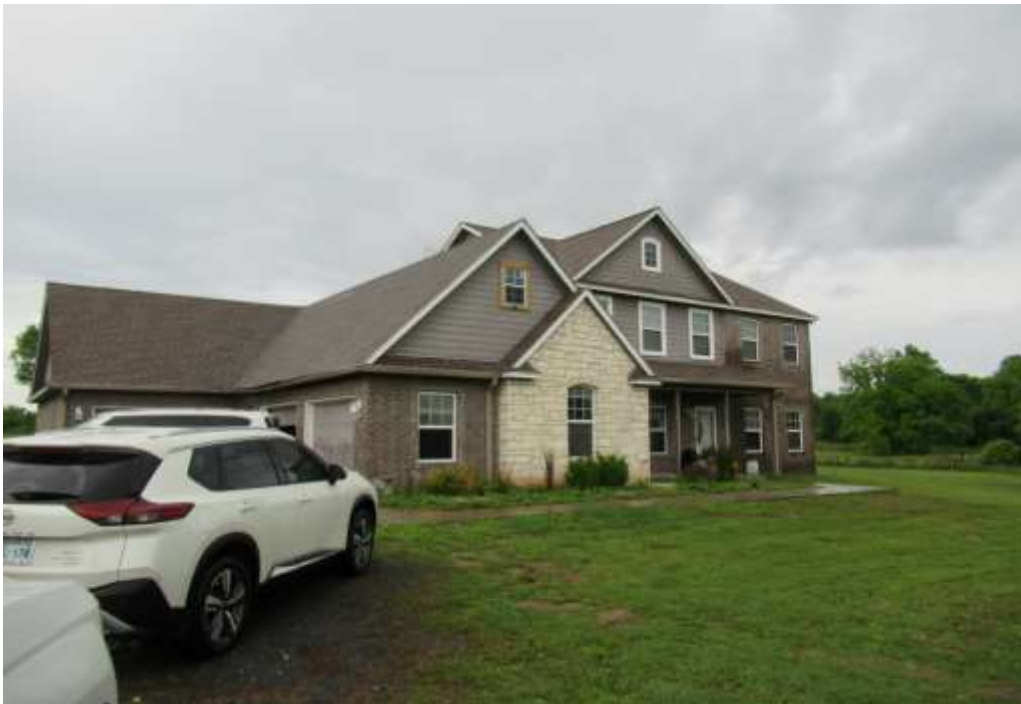
Front of the subject residence.

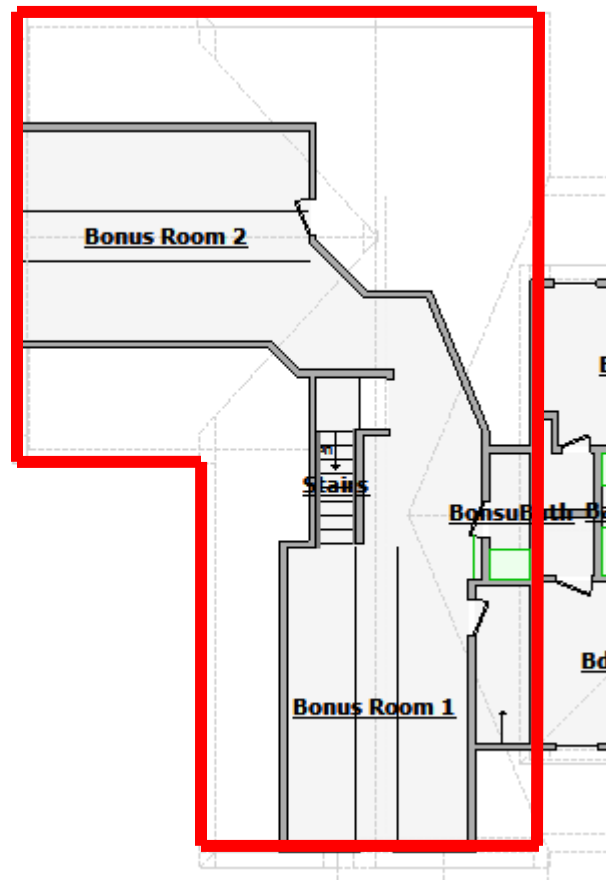
2. The design of each of the bonus rooms and these room's framing resulted in sloped ceilings. Behind the short walls of each room, heat and air equipment, including ductwork, had been installed. Although some areas of these attic spaces were somewhat separated from each other, they can still generally be considered one roof and attic space. The space of Attic 1 is within the red box below but outside the walls of the interior rooms depicted with the dark grey lines. The attic space is limited to the areas above first-floor rooms.

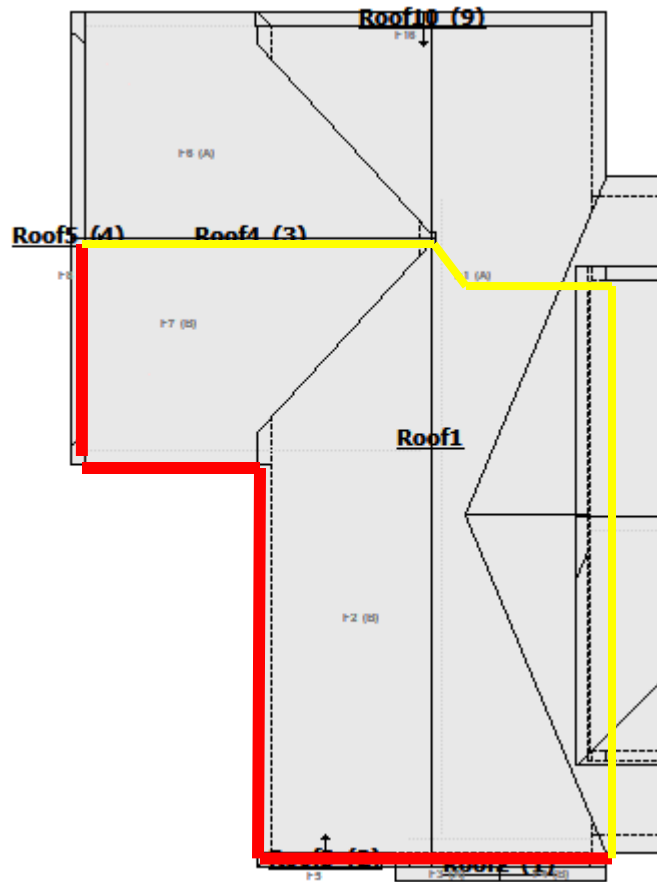
3. The follow diagram of the roof line identifies the locations within the roof's framing the fire damage was largely contained. The yellow lines represent the locations where stud wall (covered with sheetrock) and roof framing members aided in containing the fire and preventing the fire spreading to other sections of the roof and attic framing.

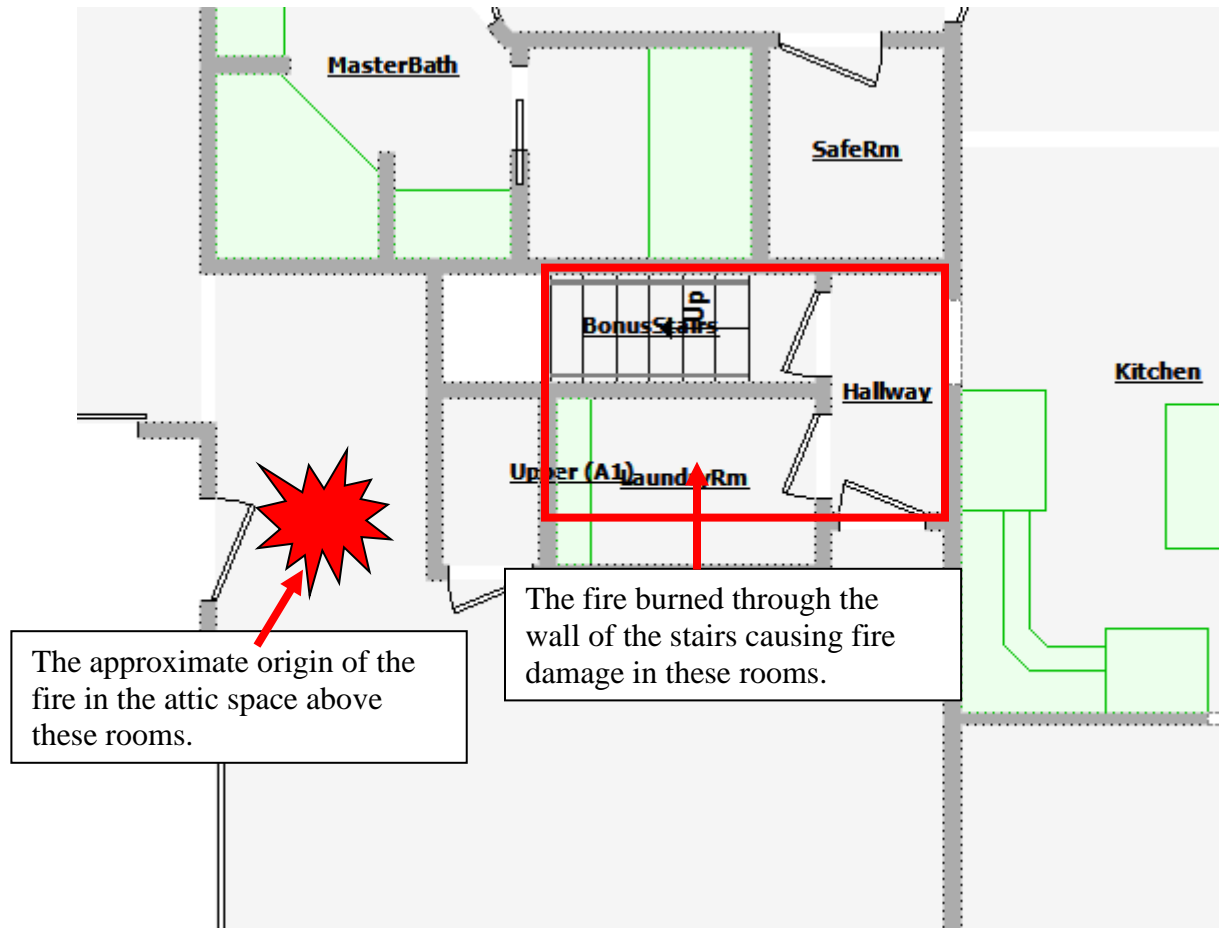
1. The fire had burned downward from the origin at the top of the stairs in the Bonus Room area. The fire damaged the finishes of the Garage Hallway and Laundry Room. Each of these rooms required the full replacement of the finishes including but not limited to: drywall, trim, cabinetry, floor tile, and light fixtures.

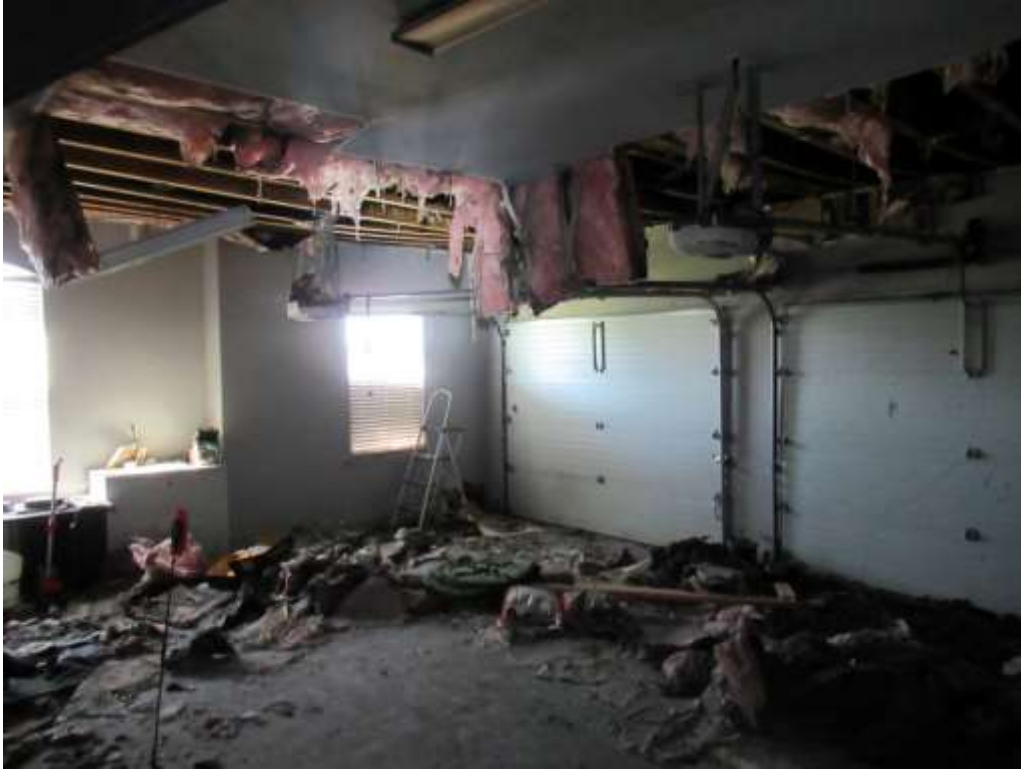
2. The ceiling of the two-car garage had been pulled down, likely by the fire department, which provided viewable access to the framing. It was found that the floor/ceiling I-beams above the garage and below Bonus Room 1 had begun to sag.

An overview of the garage looking from the entry door into the garage hall.

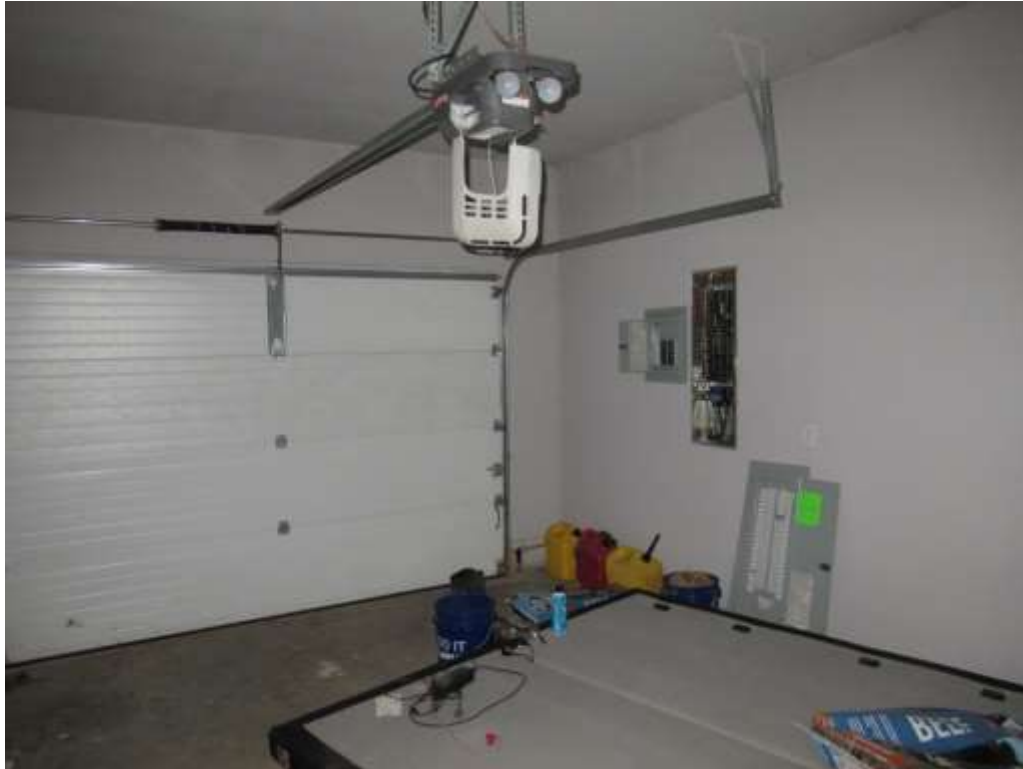
3. The finishes of the single-car garage suffered no visible fire damage. Smoke from the fire was present. However, framing above the south end of this room, in the attic space, was damaged by the fire.

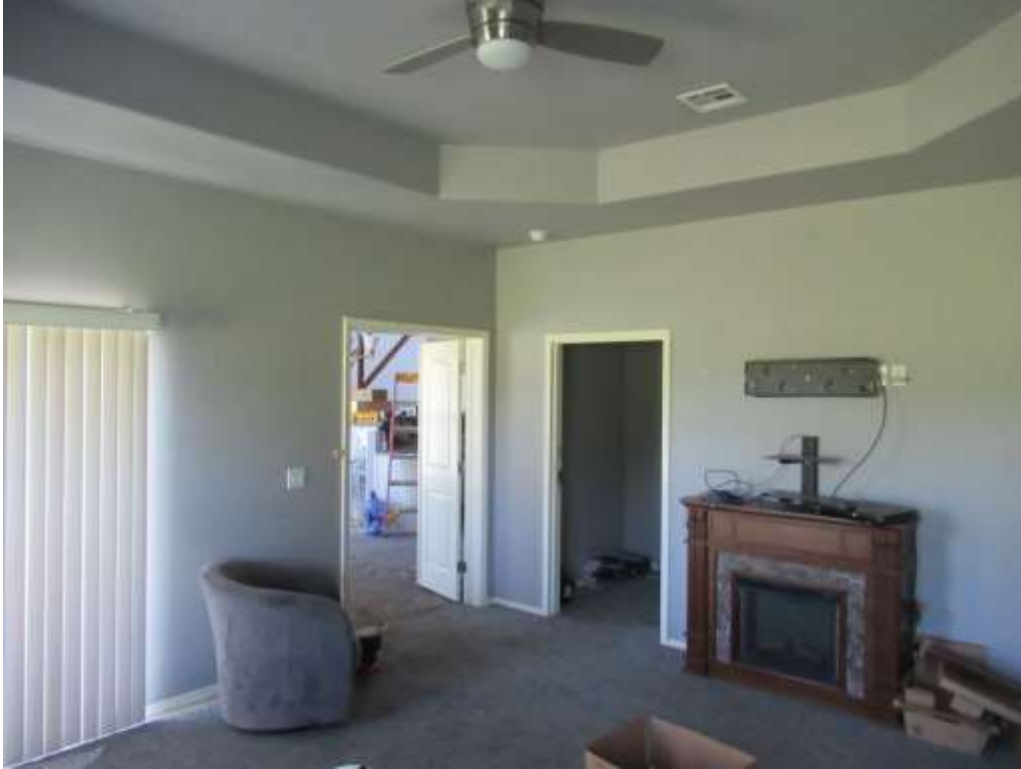
6. The remaining rooms including the Master Bedroom, Master Bathroom, Master Closets, Living Room, Powder Bath, Entry Closets, and Office all sustained soot/smoke damage. No fire damage was present. All finishes of these rooms can be remediated by cleaning and painting. The exception being the carpet and pad of the Master Bedroom and Closets. The tile floor covering ran continuously from the Garage Hallway and therefore replacement of this flooring was included in the proposed scope of work. The floor tile of the Master Bathroom and Guest Bath, as well as the white, cultured marble countertop of the Master Bathroom, were test cleaned. It was found these building components were cleanable and did not require replacement.

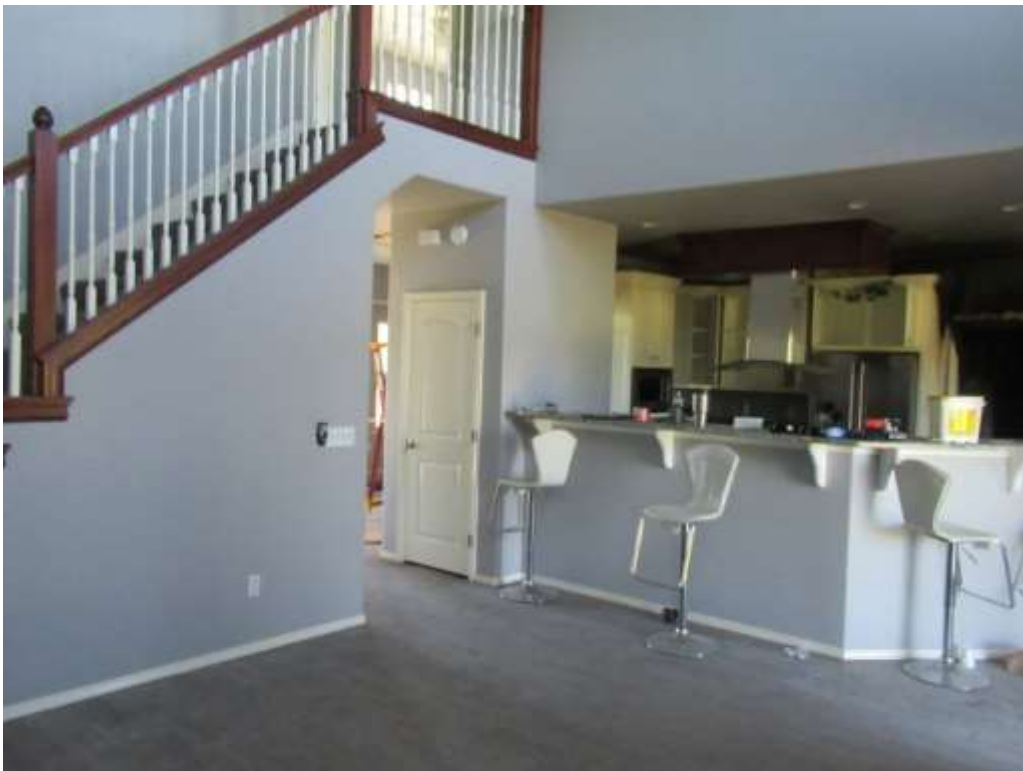
The Living Room looking towards the Kitchen and Entry

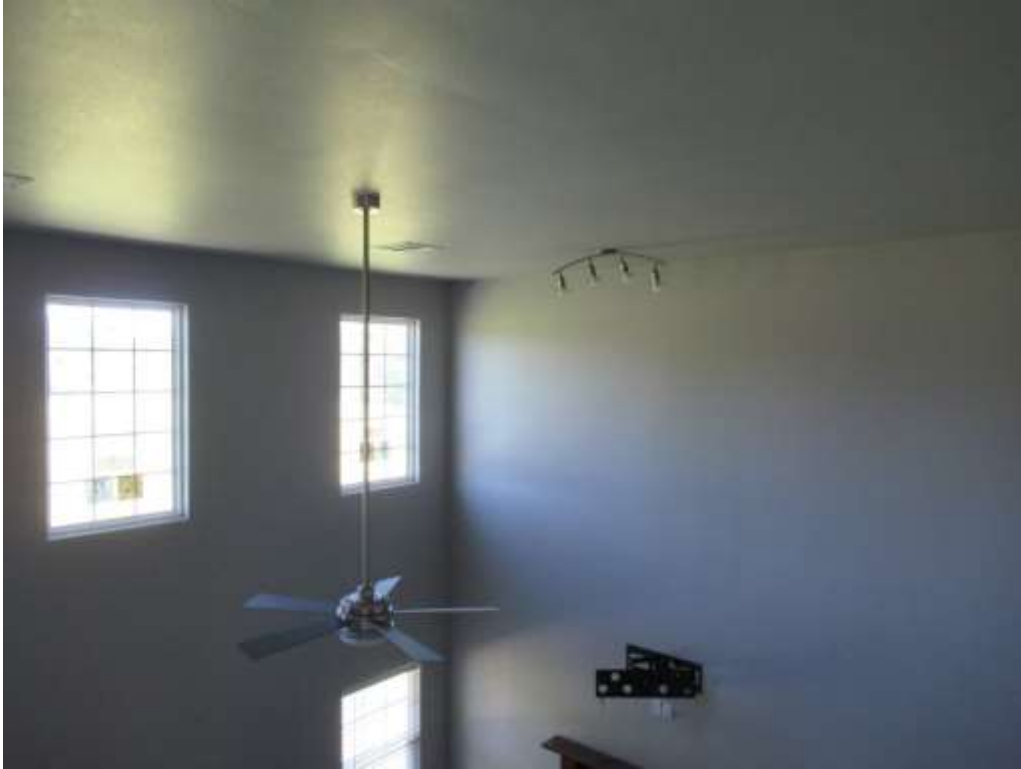
The upper sections of the Living Room.

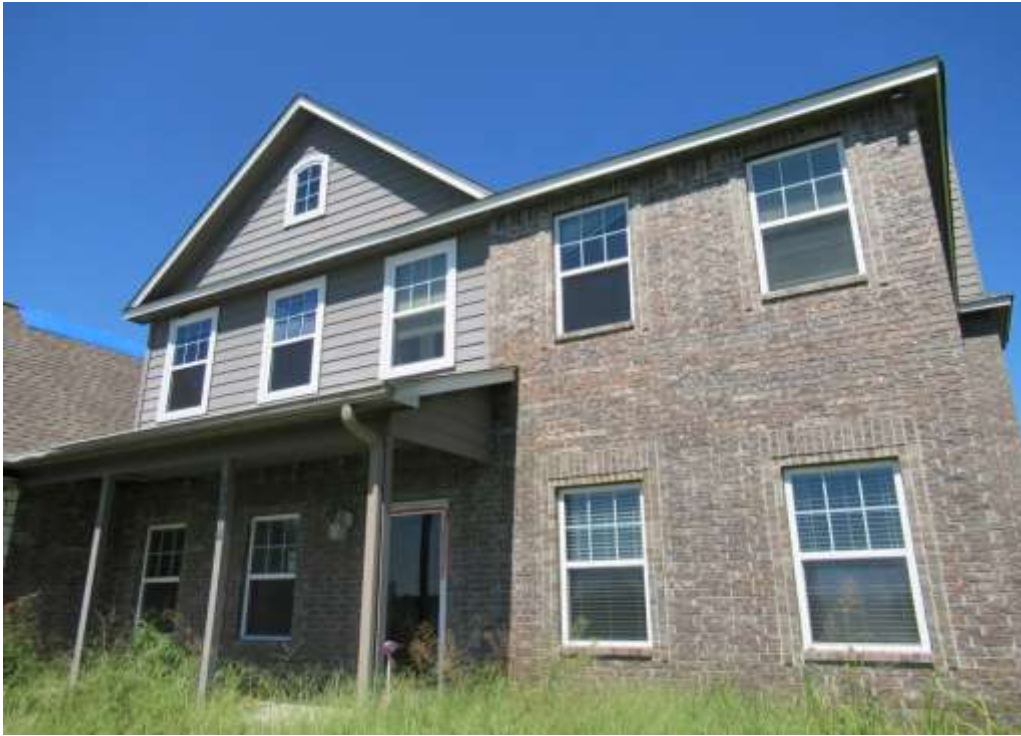
6. The east elevation of the residence was undamaged.

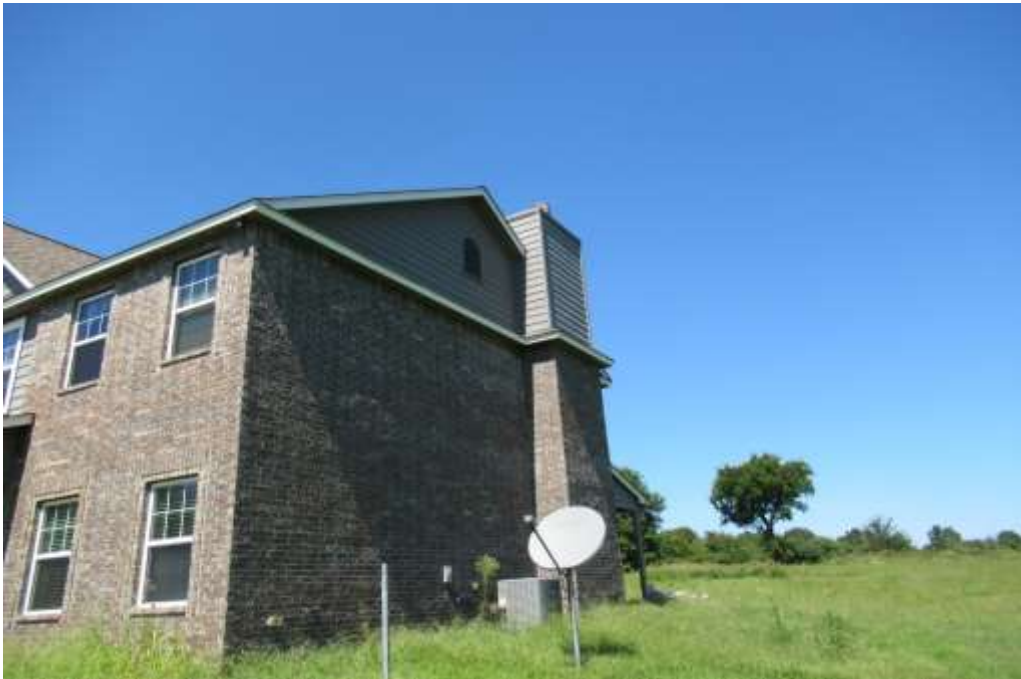
7. The back elevation was also undamaged.

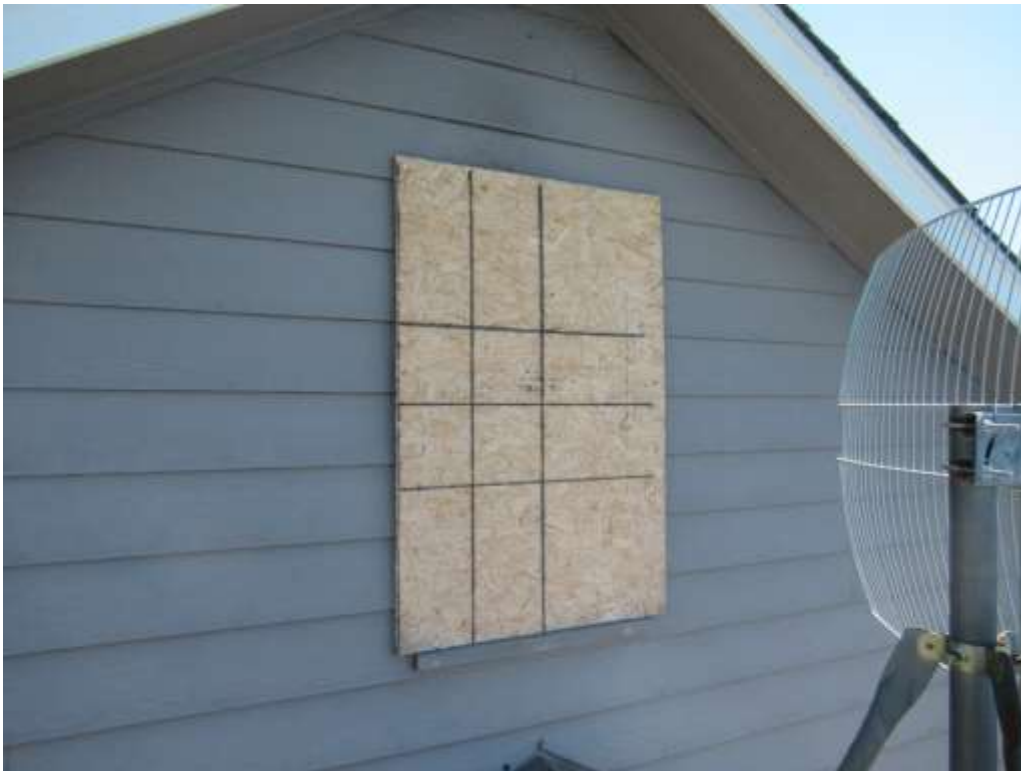
1. The shingles of the roof were found to be a 30-year laminated, composition shingle. Due to the fire damage to the framing in the Attic 1/Bonus Rooms area, much of the roof required replacement.
2. The west facing gable of the Attic 2 area exhibited smoke damage where the fire had burned through the previously discussed window.

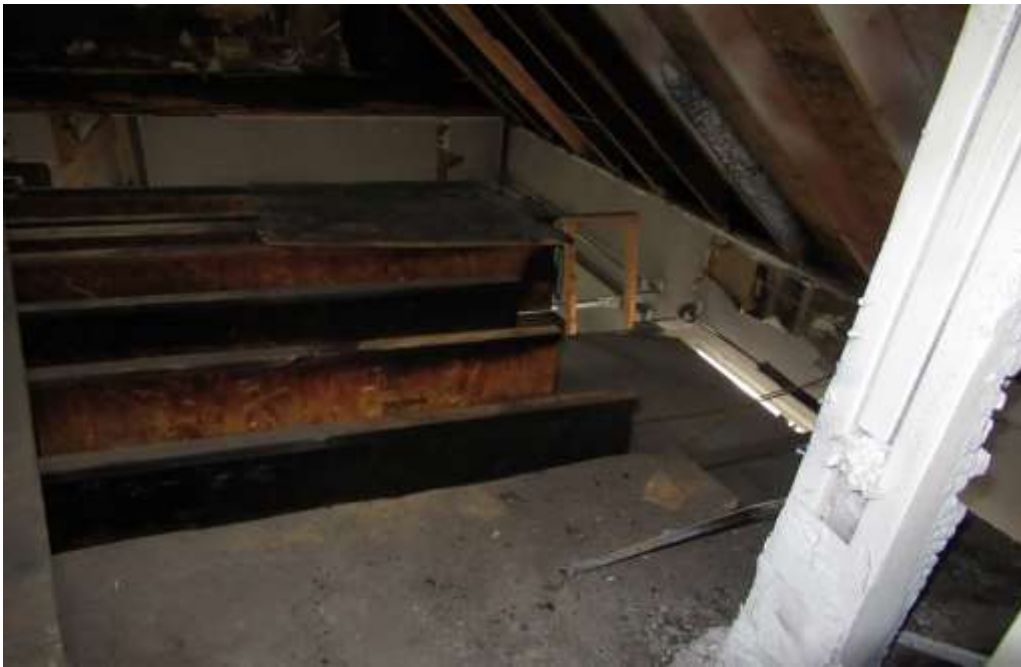
1. Much of the debris in the bonus room had been removed. The sagging floor I-beams had been cut back with a temporary wall placed below the remaining I-beams. The roof decking and some of the rafters had been replaced.

This photo is nearly the same perspective of that include at the top of page 11 of this report.

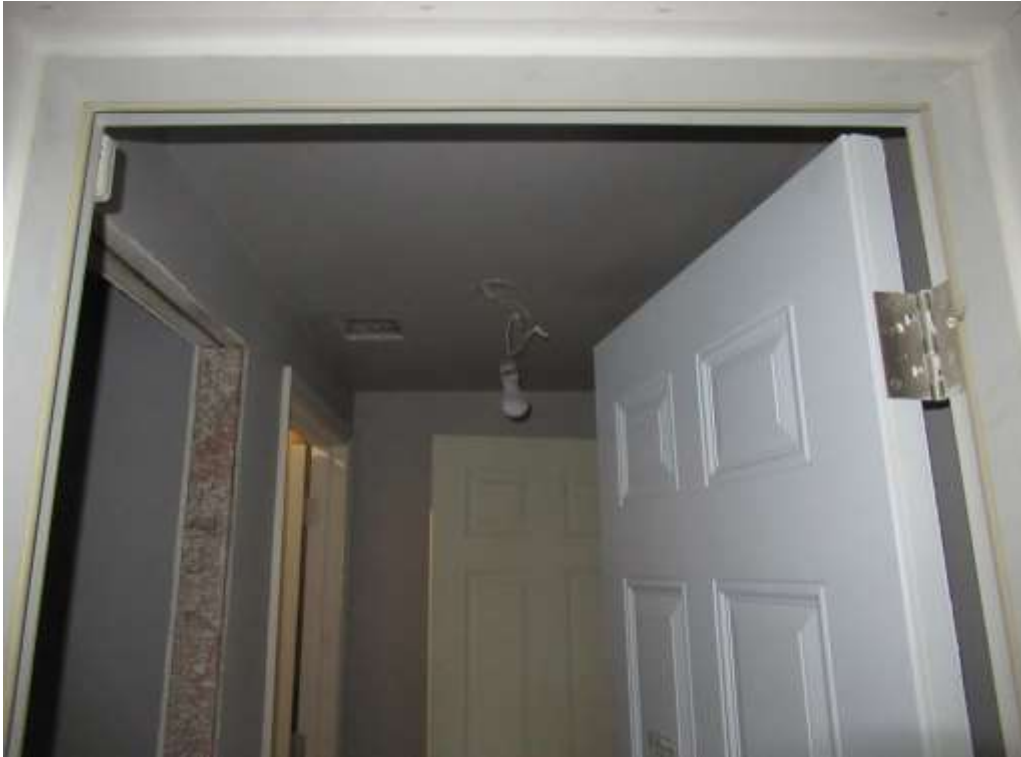
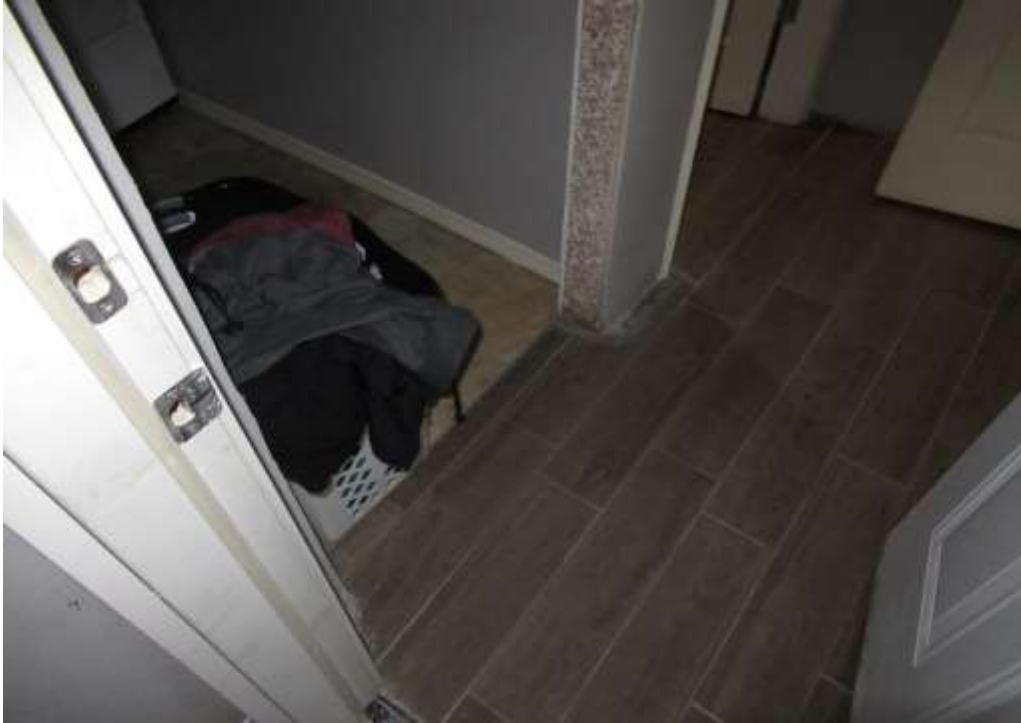
1. The fire damaged garage hallway had been partially repaired. New sheetrock, a new door to the Bonus Room Stairs, and a new door from the Garage had been installed. The room had not been painted and trim had not been installed. The flooring appeared to be the same and was not new.

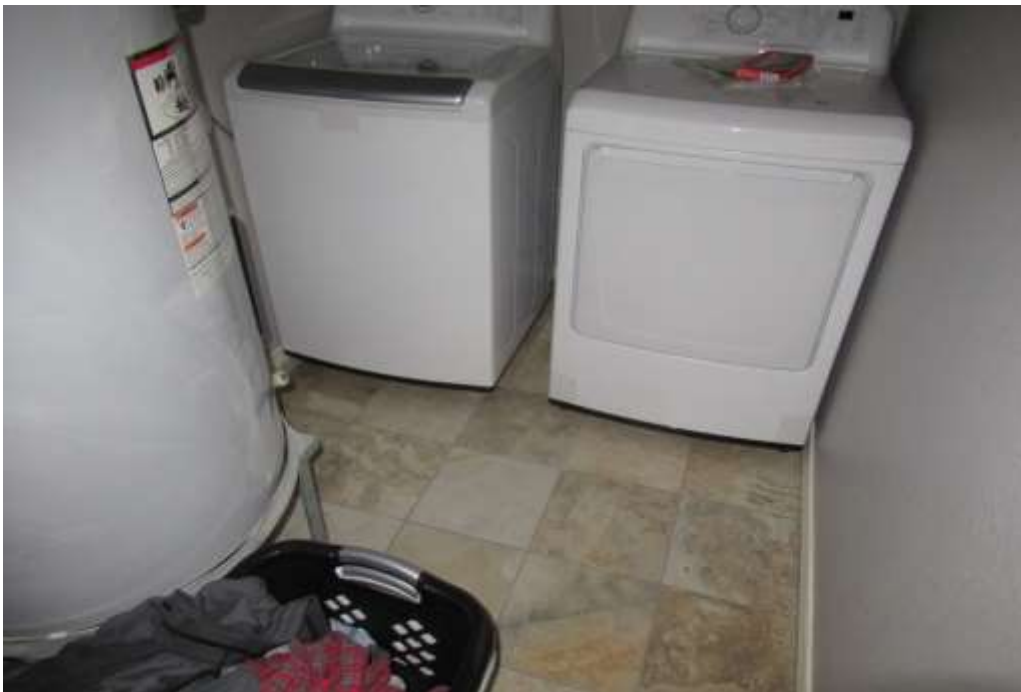
2. The Laundry Room was entirely finished indicating the finishes had not been replaced in this room. What appeared to be the original drywall, cabinets, baseboard, floor tile, and hot water heater were all still in place.

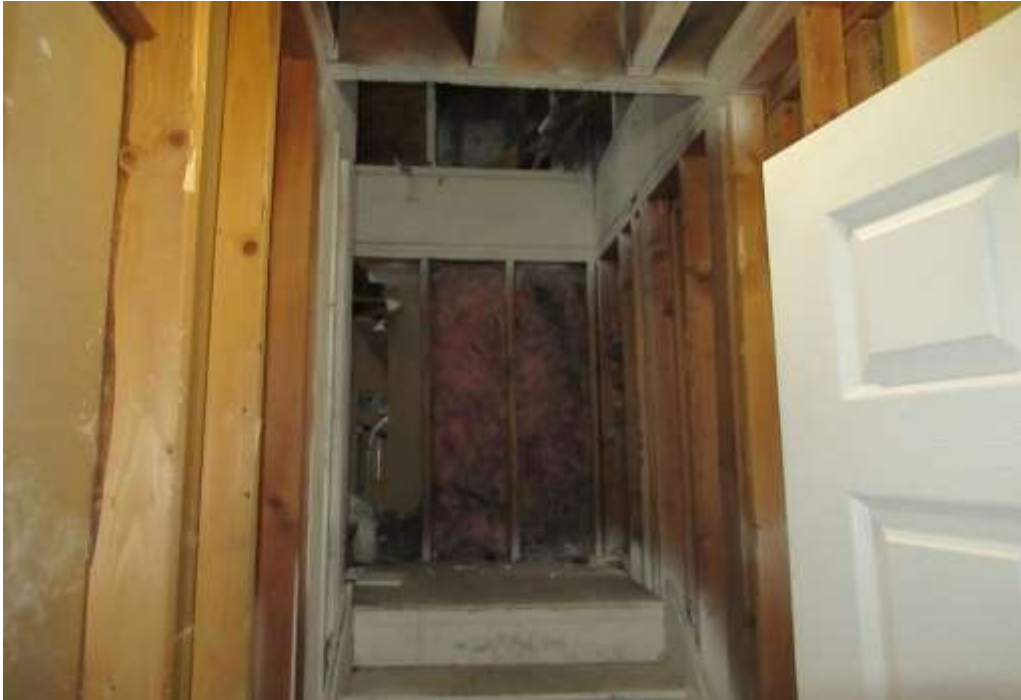
3. The stairs to the Bonus Room have largely been unrepaired except for the application of an odor control sealer.

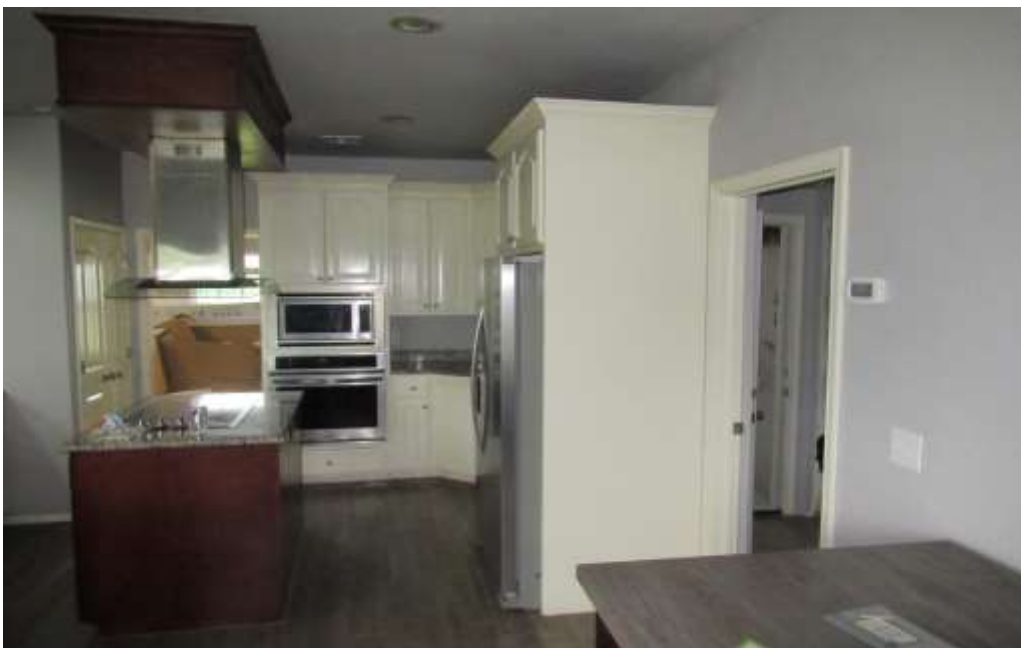
4. The fire damage to the Kitchen door casing, drywall, and cabinet bulkhead had been repaired/replaced and repainted. Kitchen fixtures had been cleaned but appeared to be the same units, including the appliances.

The kitchen from nearly the same perspective as that provided on page 20 of this report.

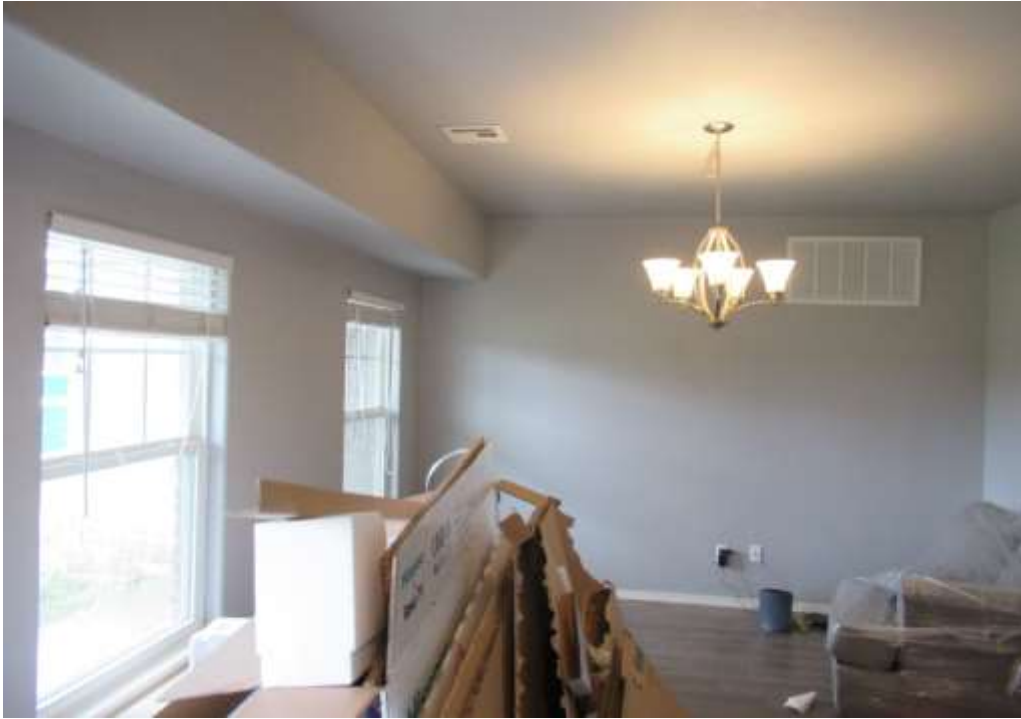
5. Drywall repairs of the holes had been made in the Dining Room and the room had been painted.

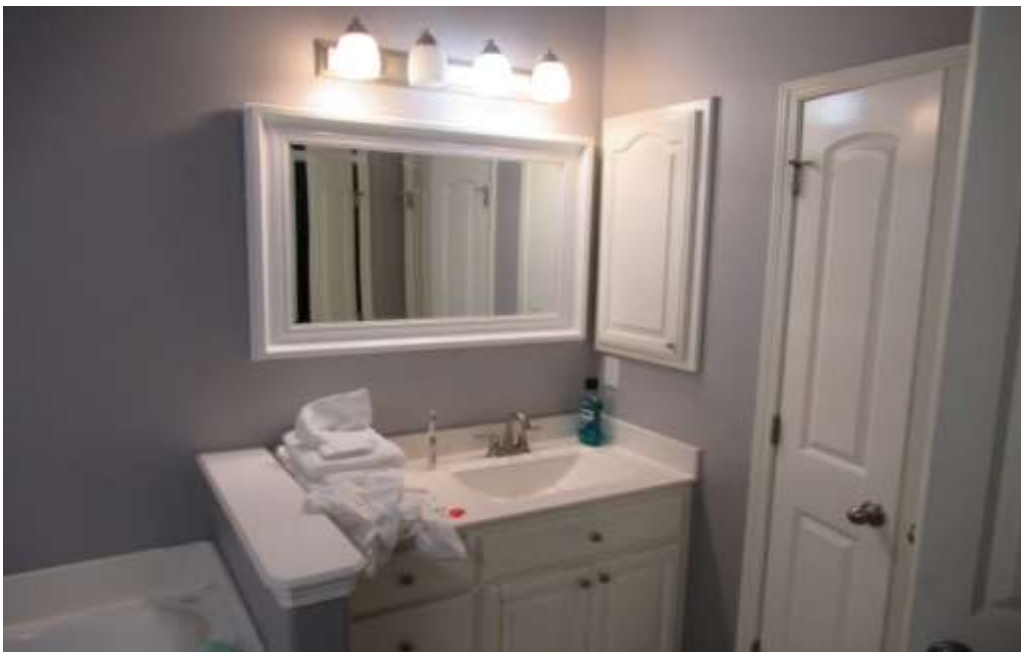
6. The remaining rooms of the Main Level had been cleaned and perhaps re-painted. All the flooring appeared to be the original flooring.

The Master Bathroom from nearly the same perspective as the photo on page 24 above.

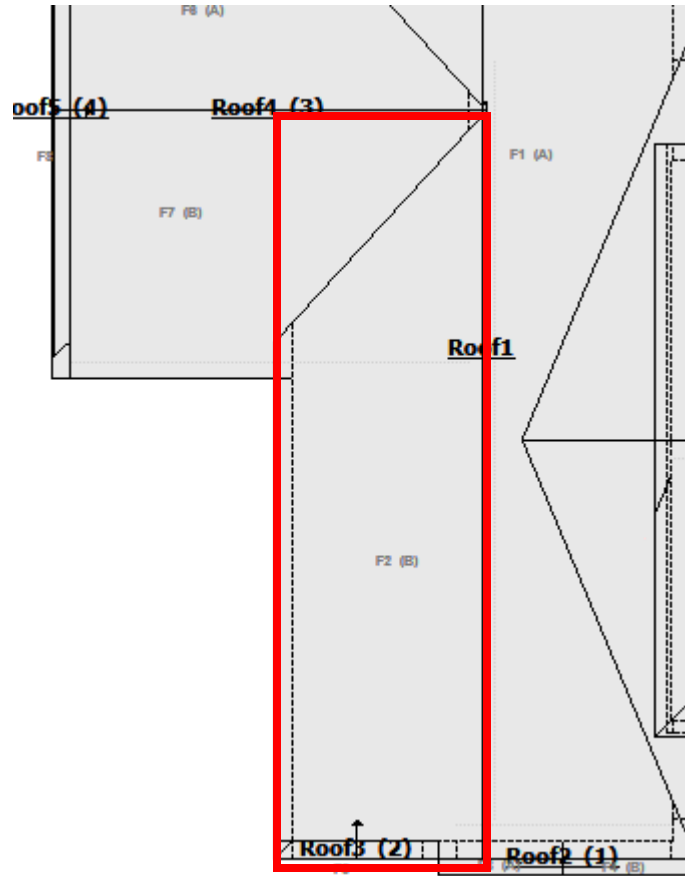
1. The roof over the two-car garage and part of the single-car garage had been replaced. The rest appeared to be original.

The interior of the box is the approximate area of the roof which was re-shingled.

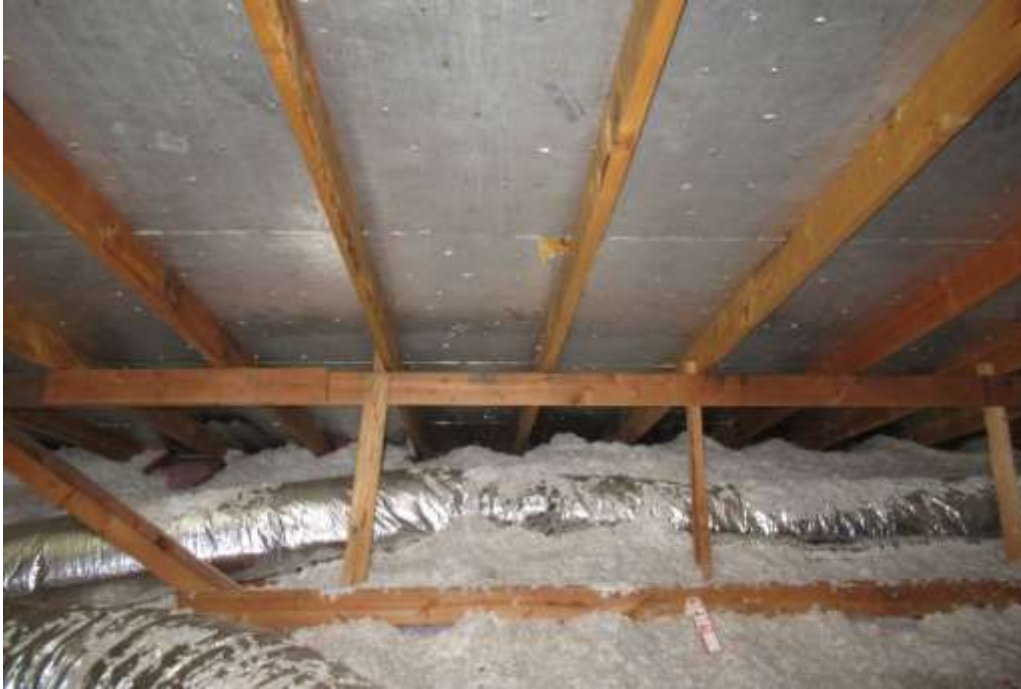
1. Williams recommends to replace all the reflective (radiant barrier) sheathing including that installed over Attic 2. Based on information and belief, this recommendation was based on a tear in the radiant barrier in one location. My observations found that the nearest tear in the radiant barrier was approximately 30' from the nearest fire damage. It is not reasonable to conclude the fire caused the tear in the reflective sheet. It is more likely this tear occurred as the sheathing was being installed. Any smoke that collected on the sheathing and framing can be remediated without replacement.
